Watson Home Inspection Services, LLC. Property Inspection Report

16466 Olalee Rd , Apple Valley Ca., 92307 Inspection prepared for: Jesse Owens & Zona Owens Agent: Ofir Andrews - Hamilton Landon

> Inspection Date: 4/2/2010 Time: 9:30 Age: 18 years Weather: Clear Front of house faces east

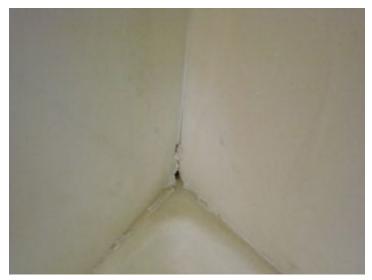
Caulking needed around perimeter.

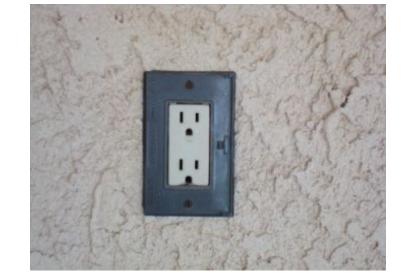
Missing cover

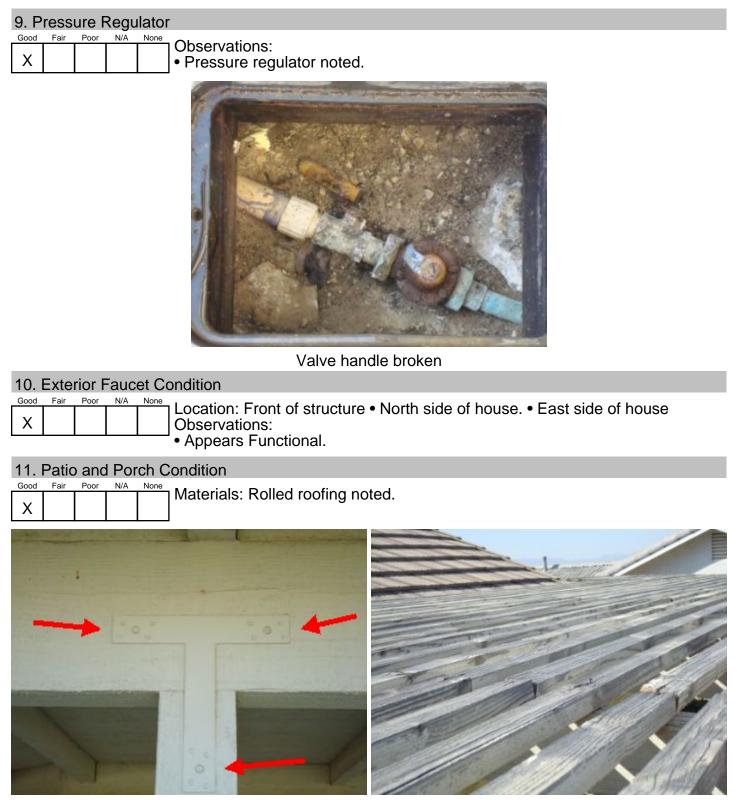
Each hole should have a lag bolt

Needs paint
