Watson Home Inspection Services, LLC.
Property Inspection Report

1234 Anywhere Lane, Yourtown Ca, 92555
Inspection prepared for: Steven Smith & Susan Smith
Agent: Alan Smith -

Inspection Date: 4/2/2010 Time: 2:30 Pm
Age: 21 years Size: 2027 sq ft
Weather: Clear
Front of house faces west.

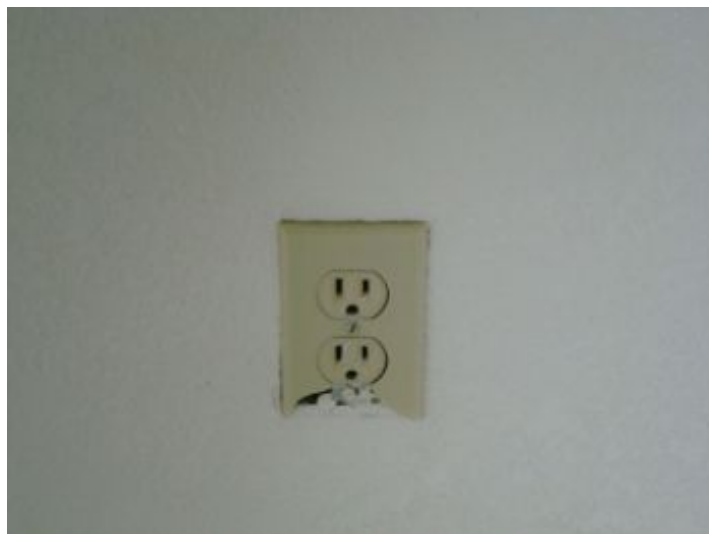
Cover should be replaced.

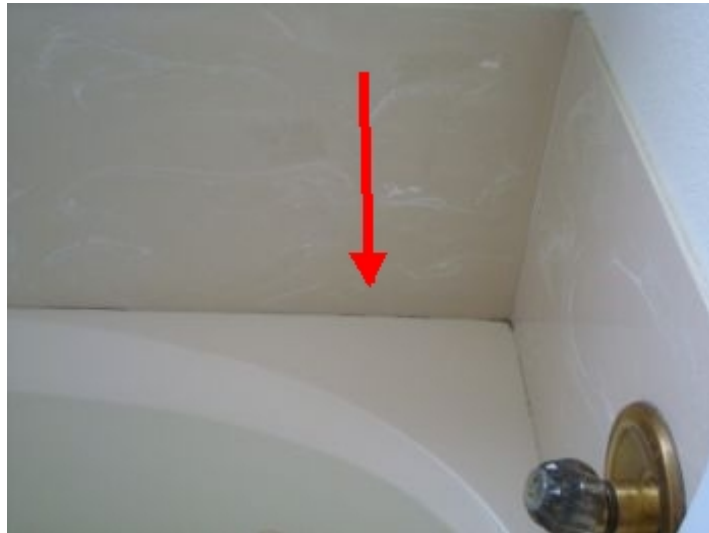
Observations:
 • Whirlpool tub observed. Tub was filled to a level above the water jets and operated to check intake and jets. The tub was then drained to check for leaks and/or damage. Pump and supply lines were not completely visible or accessible. The items tested appeared to be in serviceable condition. If a more detailed report is desired, the client is advised to consult a licensed plumber for a complete review prior to closing.
 • Some caulking repair needed at area between tub and wall.

Area should be resealed.

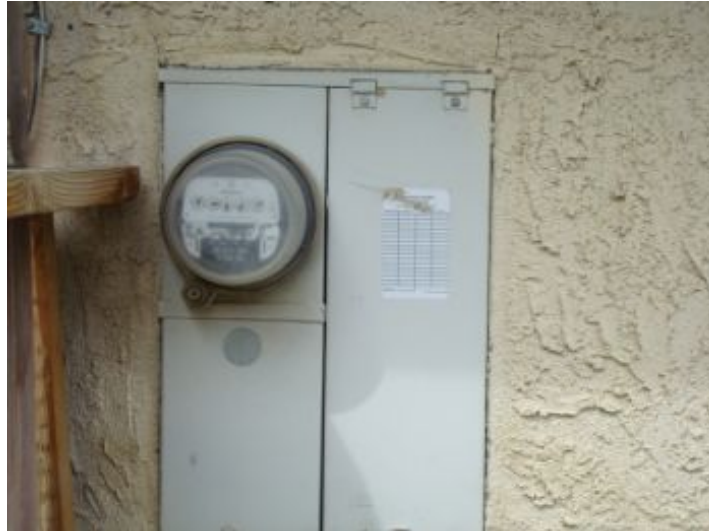
No major system safety or function concerns noted at time of inspection at main panel box.

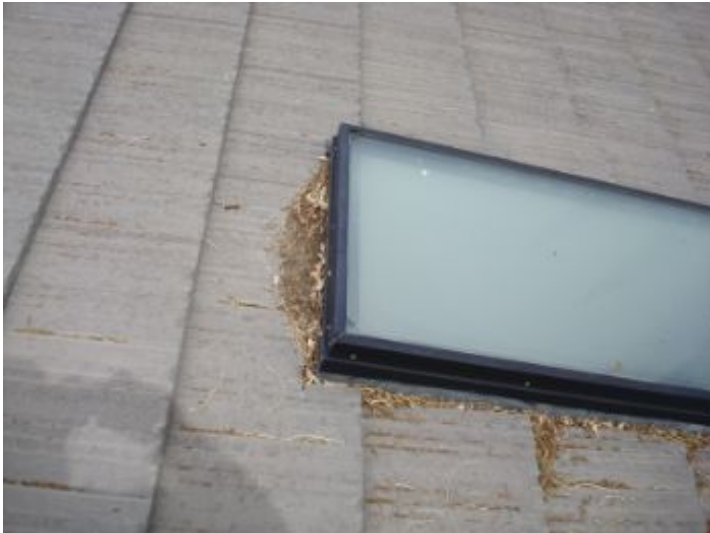
- No major system safety or function concerns noted at time of inspection.
- Clean roof areas: Significant amounts of organic debris evident.

Debris should be removed annually

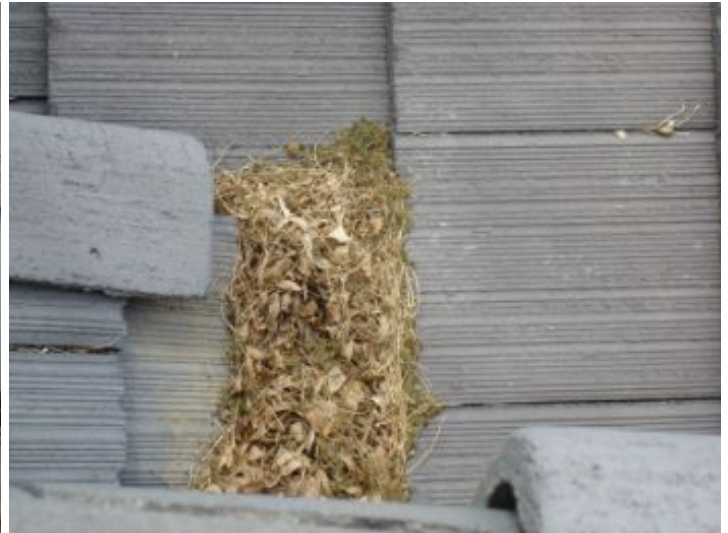
Debris

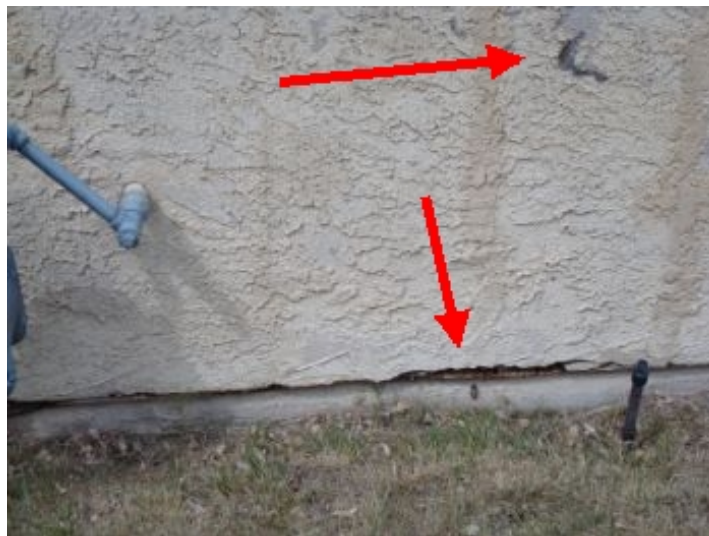
- patched areas on ceiling of entry way. Water damage on south side of house from sprinklers hitting stucco. Sprinklers should be adjusted to prevent further damage.

Water damage from sprinklers.

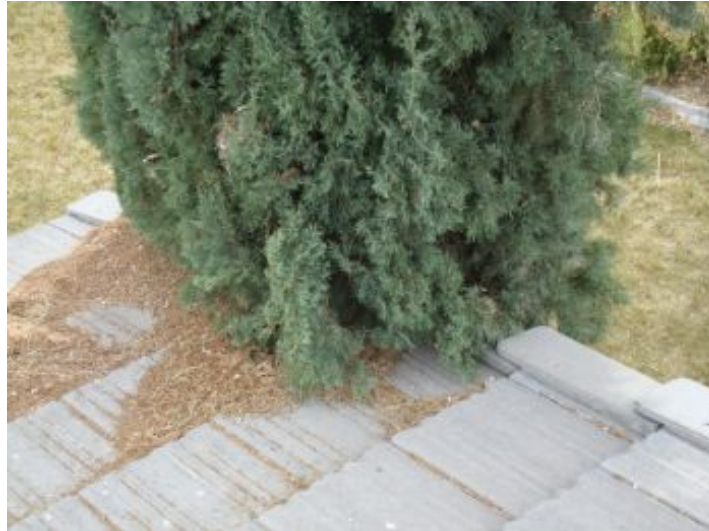
Observations:
 • Prune or remove any plants that are in contact or proximity to home to eliminate pathways of wood destroying insects.
 • Tree limbs within 10 feet of roof should be trimmed away to provide air and sunlight to roof, while minimizing debris & dampness.
 • Trim trees that are in contact or proximity to home, as branches can abrade roofing or siding.

Tree limbs within 10 feet of roof should be trimmed away to provide air and sunlight to roof, while minimizing debris & dampness.

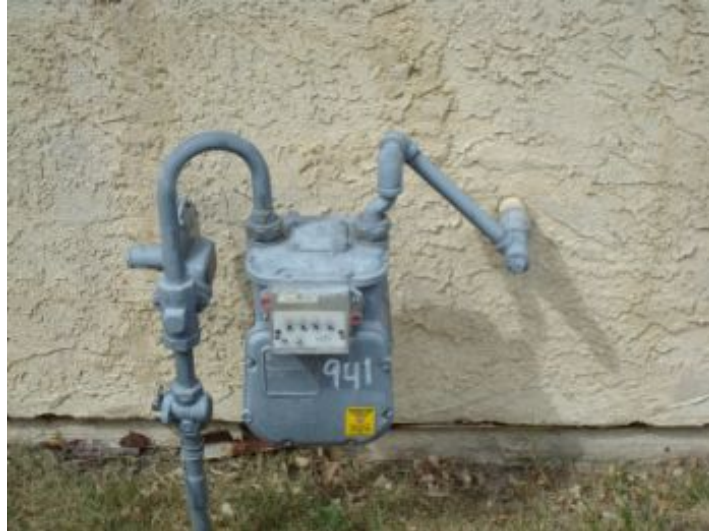
Meter located at exterior. All gas appliances have cut-off valves in line at each unit. No gas odors detected.
